**Vehicle Description**

DATE INSPECTED: 08/07/2020

145710 Toyota Hilux KUN26R SR5 Utility Double Cab 4dr Auto 4sp 4x4 3.0DT

VIN MR0FZ29G501740831  
 Compliance Date 08/2013  
 Build Date 2013  
 Odometer Reading 149005  
 Registration Number UNREG  
 Registration Expiry  
 Last Serviced See Dealer

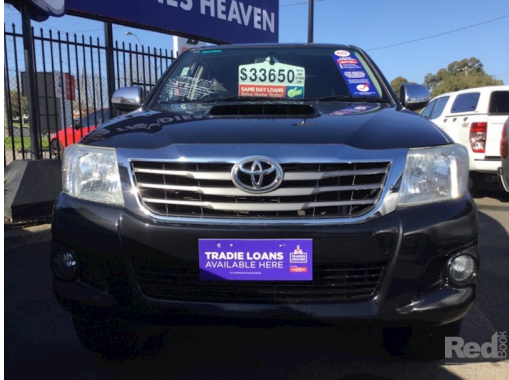
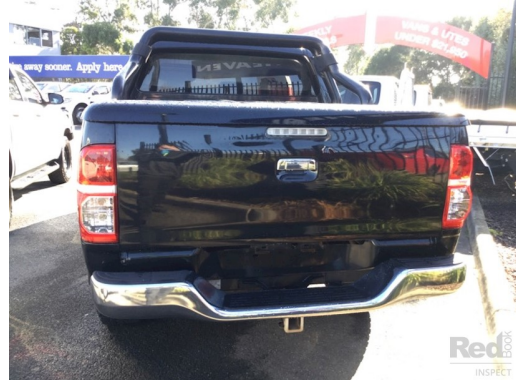
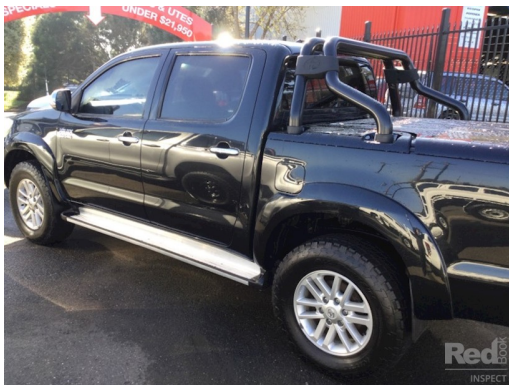
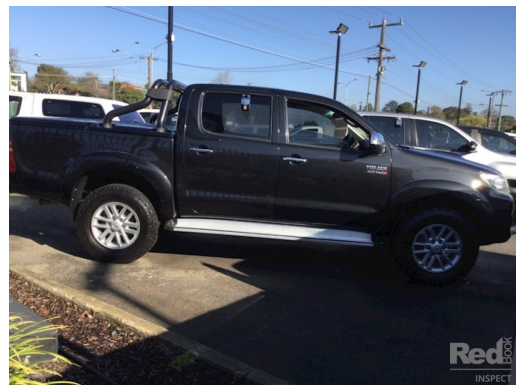
Overall this vehicle has been rated as '4 STARS' taking into consideration age, kilometres travelled and vehicle use. Vehicle presents in a well maintained condition. Note: all accessories may not have been accessible or tested at time of inspection. Possible minor inclusions and imperfections to be expected with a vehicle of these kilometres, commercial use and age
