**Vehicle Description**

DATE INSPECTED: 12/11/2020

Mercedes Benz Sprinter 2.1LT Turbo Diesel Automatic STOCK# 146380

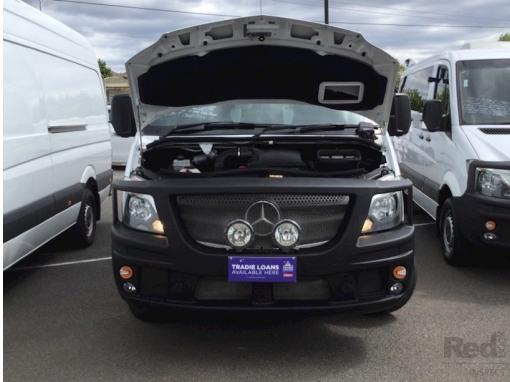
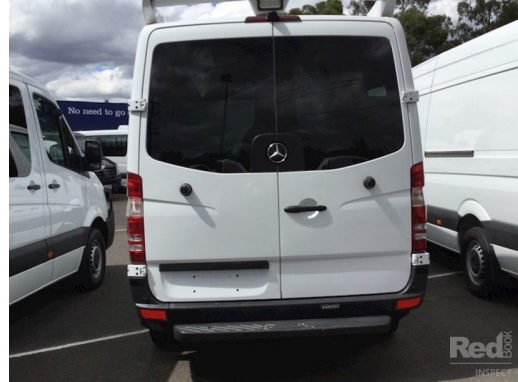
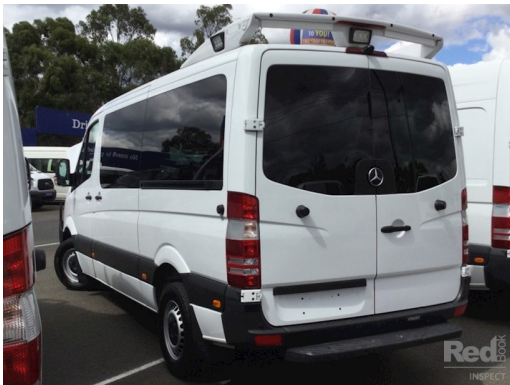
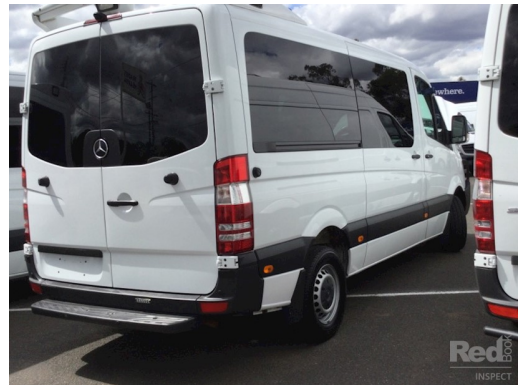
Overall this vehicle has been rated as '4 STARS' taking into consideration age and kilometres travelled. Vehicle presents in a well maintained condition. Possible minor inclusions and imperfections to be expected with a vehicle of these kilometres and age which is used for commercial use
