Vehicle Description

DATE INSPECTED: 25/11/2020

146384 Toyota Hiace KDH221R Van High Roof Super LWB 5dr Auto 4sp 3.0DT

VIN JTFPT22P300019368
 Compliance Date 03/2017
 Build Date 2017
 Odometer Reading 72322
 Registration Number UNREG
 Registration Expiry
 Last Serviced See Dealer

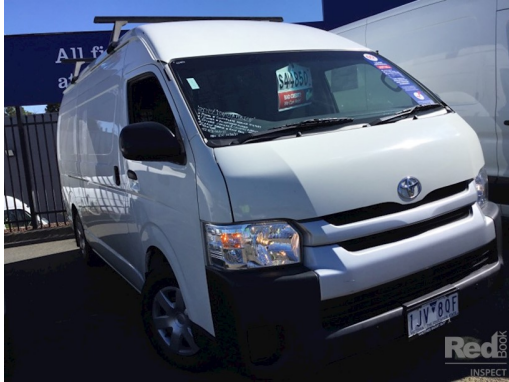
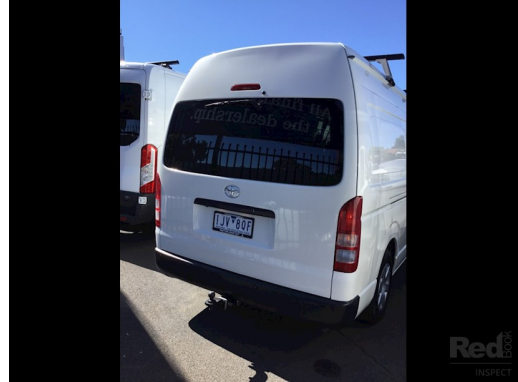
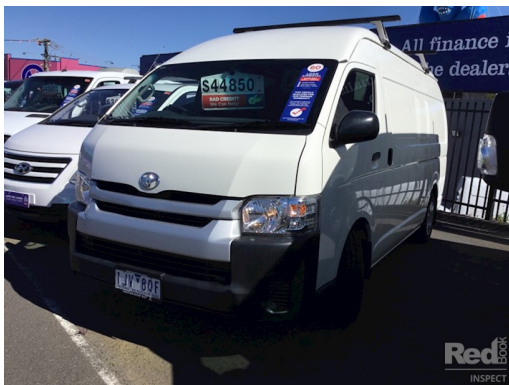
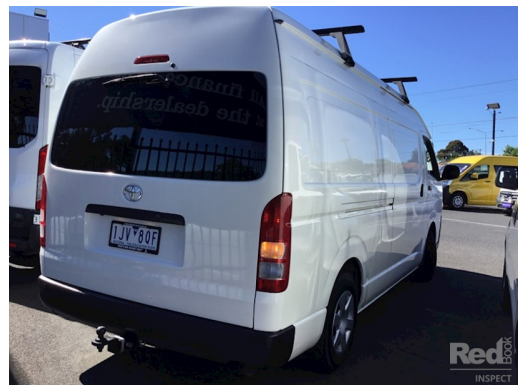
Overall this vehicle has been rated as '4 STARS' taking into consideration age, kilometres travelled and vehicle use. Vehicle presents in a well maintained condition. Note: all accessories may not have been accessible or tested at time of inspection. Possible minor inclusions and imperfections to be expected with a vehicle of these kilometres, age and use.
